**Flood Control Project Maintenance
Levee Inspections****2013 Channel Summary Report****Overall Unit and Item Ratings****Adin Community Service District**

Flood Control Project Maintenance**Unit Cover Sheet****2013 Channel Inspection Results****Adin Community Service District**

**Flood Control Project Maintenance
Channel Inspections**

Adin Community Service District

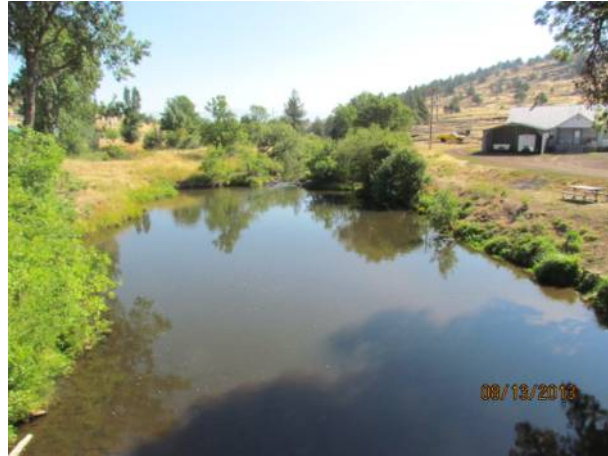
Levee Mile Report Line	1
Start Levee Mile	0.00
End Levee Mile	0.00
Location	
Category	Channels
Item	Vegetation & Obstructions

View from Main Street (Highway 299) towards the gauging station.

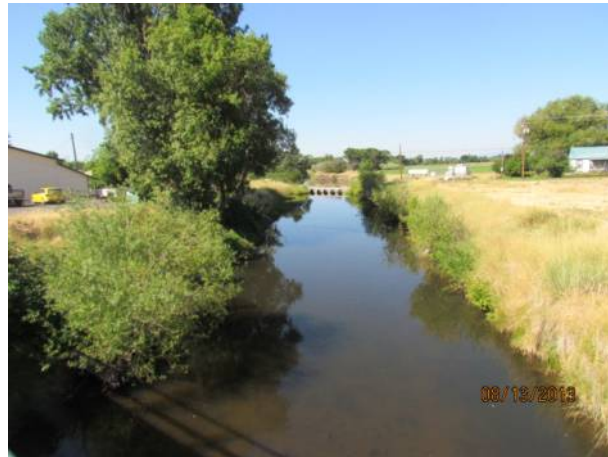
Levee Mile Report Line	6
Start Levee Mile	0.00
End Levee Mile	0.00
Location	
Category	Channels
Item	Vegetation & Obstructions

View from Main Street (Highway 299) towards the Ash St. low water crossing.

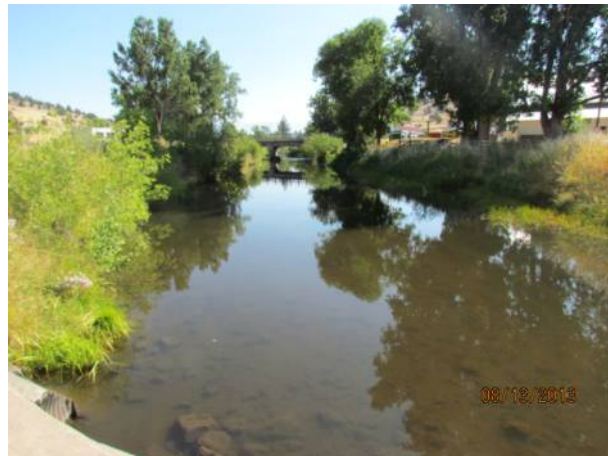
Levee Mile Report Line	11
Start Levee Mile	0.00
End Levee Mile	0.00
Location	
Category	Channels
Item	Vegetation & Obstructions

View of the channel from Ash Street low water crossing.

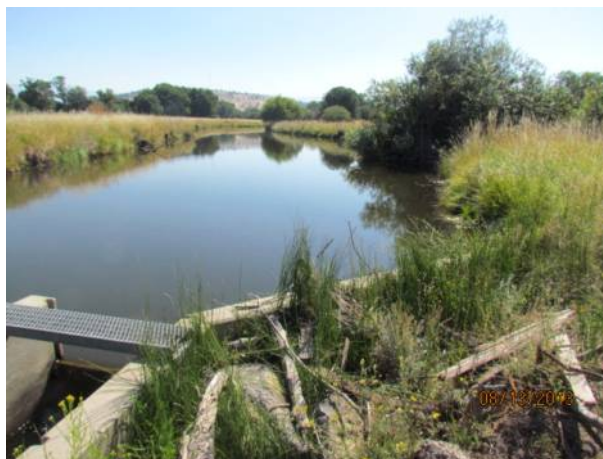
Levee Mile Report Line	21
Start Levee Mile	0.00
End Levee Mile	0.00
Location	
Category	Channels
Item	Vegetation & Obstructions

View of the upstream side of the weir.

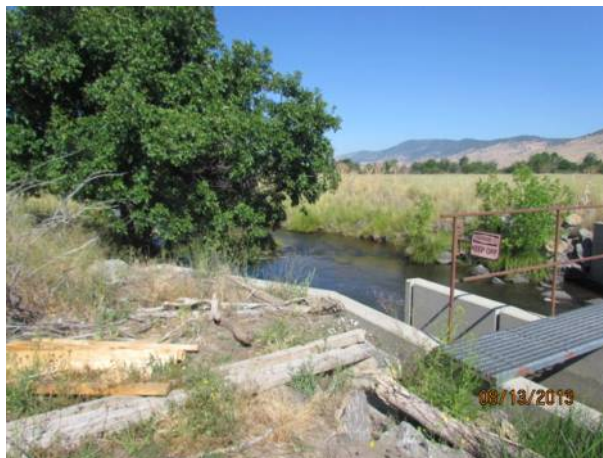
Levee Mile Report Line	26
Start Levee Mile	0.00
End Levee Mile	0.00
Location	
Category	Channels
Item	Vegetation & Obstructions

View of the downstream side of the dam & fish ladder constructed by Dept. of Fish & Game in October 1999.

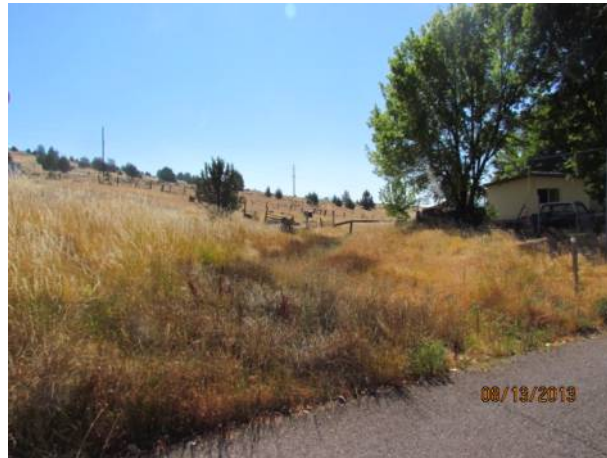
Levee Mile Report Line	1
Start Levee Mile	0.00
End Levee Mile	0.00
Location	
Category	Channels
Item	Vegetation & Obstructions
Upstream at Adin Street. Minimal growth in channel.	
rduffey_c_20130819_028.JPG

LMR No.	Check Point	View	Item	Location	Rating	Inspector Comment	GPS Latitude & Longitude	Photo	Issue No
1	Adin Street	Up	Vegetation & Obstructions		A	Inspector Comments: Remove all vegetation in channel before winter.	41.195370 ° -120.943190 °	Y	1
2		Up	Shoaling / Sedimentation		A		41.195370 ° -120.943190 °		2
3		Up	Revetments		A		41.195370 ° -120.943190 °		4
4		Up	Encroachments		A		41.195370 ° -120.943190 °		5
5		Down	Vegetation & Obstructions		A	Inspector Comments: Remove all vegetation in channel before winter.	41.195370 ° -120.943190 °	Y	6
6		Down	Shoaling / Sedimentation		A		41.195370 ° -120.943190 °		7
7		Down	Erosion / Bank Caving		A		41.195370 ° -120.943190 °		3
8		Down	Erosion / Bank Caving		A		41.195370 ° -120.943190 °		8
9		Down	Revetments		A		41.195370 ° -120.943190 °		9
10		Down	Encroachments		A		41.195370 ° -120.943190 °		10
11	Main Street	Up	Vegetation & Obstructions		A	Inspector Comments: Remove all vegetation in channel before winter.	41.196350 ° -120.944250 °	Y	11

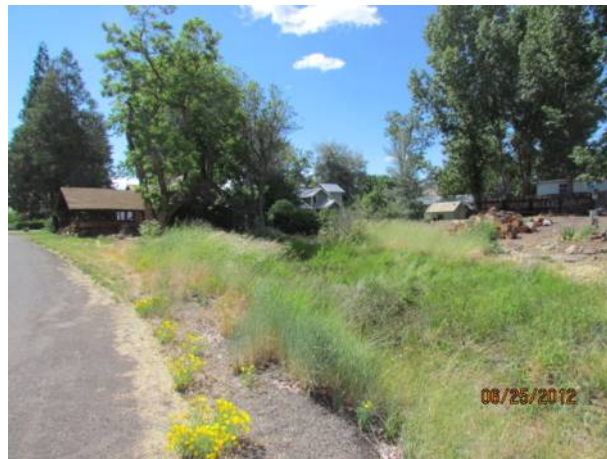
Levee Mile Report Line	5
Start Levee Mile	0.00
End Levee Mile	0.00
Location	
Category	Channels
Item	Vegetation & Obstructions
Downstream from Adin Street. Minimal growth in channel.	
rduffey_c_20130619_018.jpg

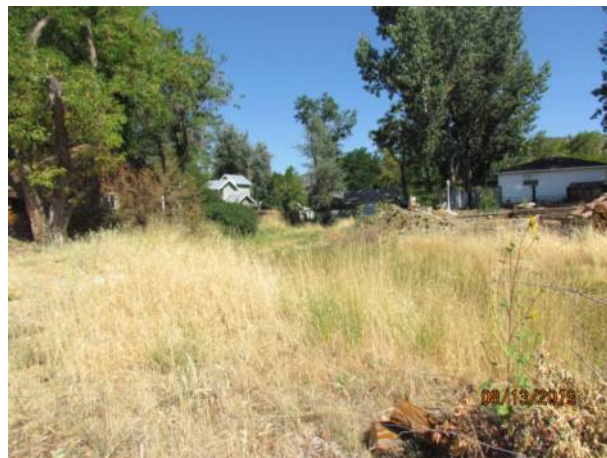
Levee Mile Report Line	5
Start Levee Mile	0.00
End Levee Mile	0.00
Location	
Category	Channels
Item	Vegetation & Obstructions
Downstream from Adin Street. Minimal growth in channel.	
rduffey_c_20130819_029.JPG

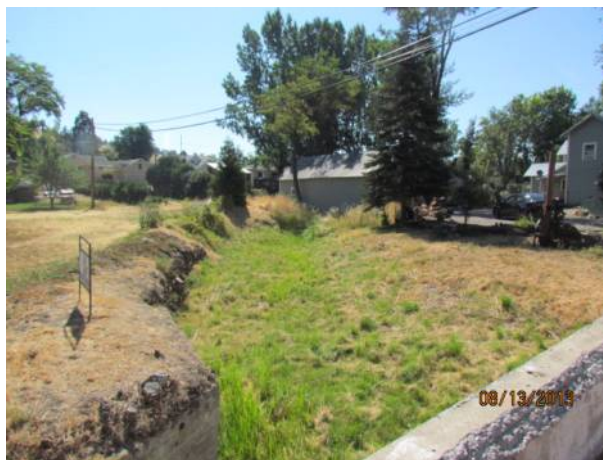
Levee Mile Report Line	11
Start Levee Mile	0.00
End Levee Mile	0.00
Location	
Category	Channels
Item	Vegetation & Obstructions
Upstream from Main Street. Minimal growth in channel.	
rduffey_c_20130819_030.JPG

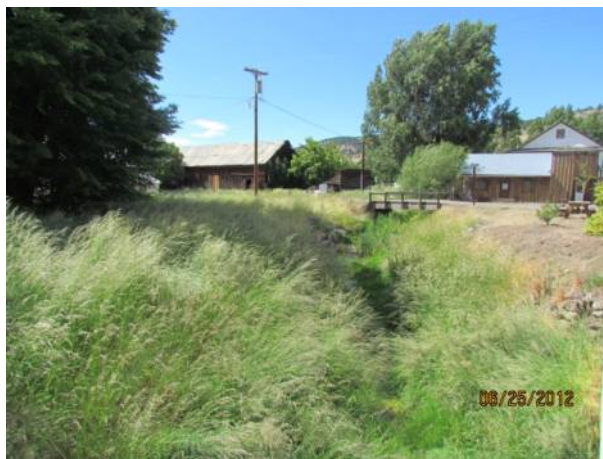
Levee Mile Report Line	16
Start Levee Mile	0.00
End Levee Mile	0.00
Location	
Category	Channels
Item	Vegetation & Obstructions
View of the minimal vegetation in channel.	
rduffey_c_20130619_020.jpg

12		Up	Shoaling / Sedimentation		A		41.196350 ° -120.944250 °		12
13		Up	Erosion / Bank Caving		A		41.196350 ° -120.944250 °		13
14		Up	Revetments		A		41.196350 ° -120.944250 °		14
15		Up	Encroachments		A		41.196350 ° -120.944250 °		15
16		Down	Vegetation & Obstructions		A	Inspector Comments: Remove all vegetation from channel before winter.	41.196350 ° -120.944250 °	Y	16

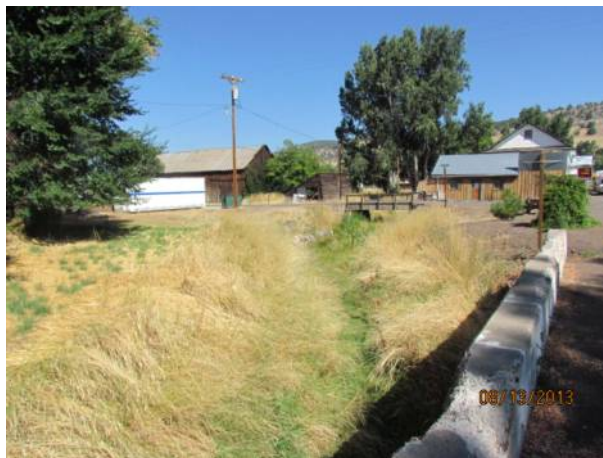
Levee Mile Report Line	16
Start Levee Mile	0.00
End Levee Mile	0.00
Location	
Category	Channels
Item	Vegetation & Obstructions
View of the minimal vegetation in channel.	
rduffey_c_20130819_031.JPG
